Final Report

June 1969

VULNERABILITY OF THE ALBUQUERQUE WATER SUPPLY SYSTEM

STANFORD RESEARCH INSTITUTE
Menlo Park, California 94025 • U.S.A.

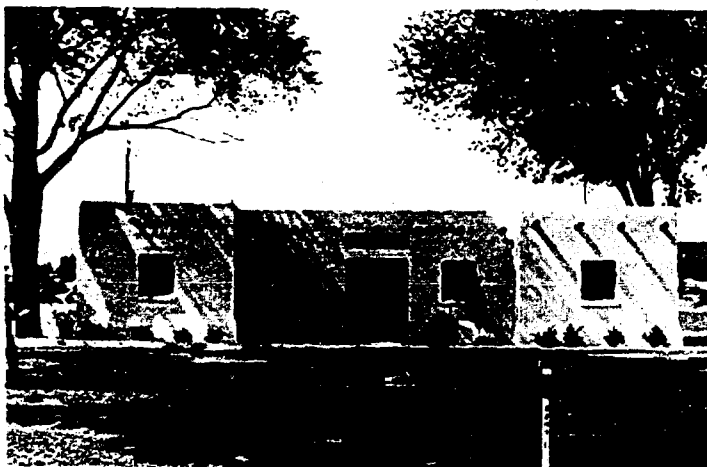
FIGURE 6 TYPICAL BOOSTER PUMP SHELTERS

Most of the plants are sheltered in masonry buildings, but there are several in sheet metal structures and three in reinforced concrete structures. The location of these stations are shown on Figure 3 and their relation to the system is shown on the schematic diagram of Figure 5. The pumps and capacities at each station are listed in Table 2. Typical pump house structures are shown in Figure 6.

MASONRY SHELTER
Eubank Pump Station

SHEET METAL SHELTER
Santa Barbara Pump Station

REINFORCED CONCRETE SHELTER
Yale Pump Station

There are 26 booster pumping stations in the general system which provide for lifting water from each of the lower zones into the next higher one, and for transferring water from one side of the river to the other. Four of the 26 booster stations have two pumps each that are equipped with gas-fueled auxiliary engines. A 27th booster station serves a small area that is not interconnected with the general system. Equipment descriptions are given in Appendix A.
